Restoration Process of Ship's Masthead

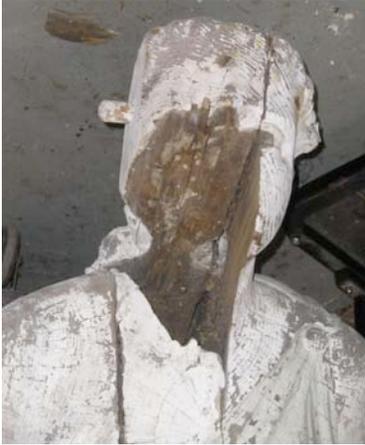
Figure 1.

Here is an example of a French ship masthead treated with repeated coats of whitewash. Years of weathering, wear and poor storage conditions had created internal rot damage, which caused separation and warping of the wood. These types of sculptural works were often created in sections and assembled, through a process of lamination, and in this case, an entire section of the face and neck had come apart at the seams (Fig 1). This was due to checking of the wood along weakened lamination lines. Fortunately this major piece had not been lost. Further examination revealed that a large internal dowel had once held the right side of the head in place. This section was missing entirely (Fig 2).
